CIVIL ENGINEERS.

VOL. LIII.

No.		PAGE.
978	**THE COLLAPSE OF A BUILDING DURING CONSTRUCTION.**	
	By **H. de B. Parsons**	1
	Discussion on Paper No. 978:	
	By Nathaniel Roberts	10
	C. J. Tilden	13

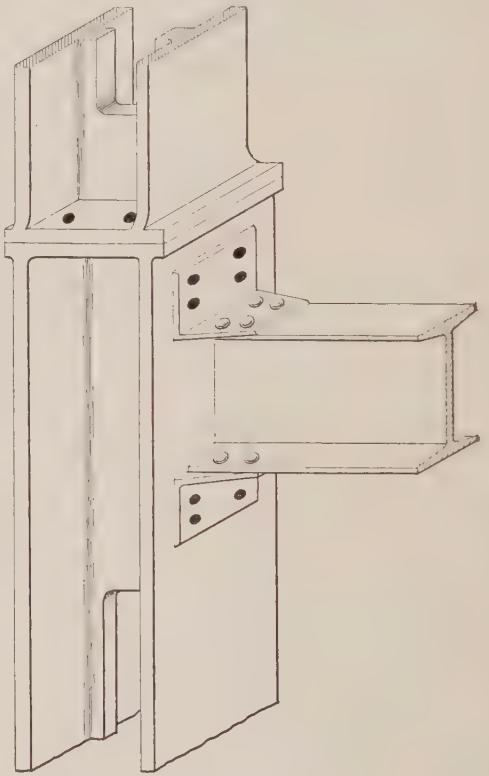
Fig. 7.

The connections shown in Fig. 7 were used in the narrow skeleton-constructed buildings, No. 64 Fulton Street, 25 ft. wide and nine stories high, and No. 708 Broadway, 25 ft. wide and ten stories high, where beams were spaced at about 6.5 ft. centers and were connected at each end to cast-iron I-shaped columns in the lower stories, and to channel-steel columns in the upper stories. Where the floor loads were too heavy for the bolts shown in Fig. 7, connections were made to the column seats as shown in Fig. 8.

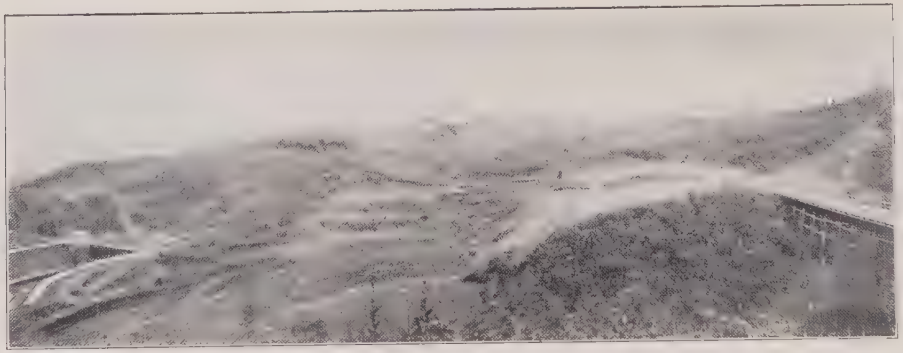
FIG. 1.—LOOKING SOUTH FROM RIDGE NEAR CABLE RAILWAY BRIDGE, SHOWING RESERVOIRS NOS. 3 AND 4, PART OF SLIDING LAND AND SHAFT NO. 1.

FIG. 2.—LOOKING WEST FROM CITY PARK, SHOWING RESERVOIR NO. 3 AND THE SLIDING LAND. PHOTOGRAPHS TAKEN SEPTEMBER 22D, 1897.

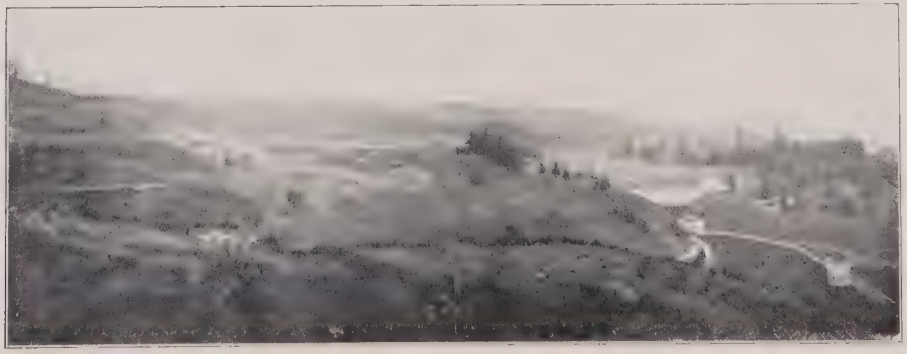
No. 3.—Looking North from the Summit of the Ridge, near the Old Ball Ground, Showing the Gate-House, Power-House and Parts of Reservoirs Nos. 3 and 4.
Photograph Taken September 28th, 1897.
